NATIONAL TRANSPORTATION SAFETY BOARD

MATERIALS LABORATORY FACTUAL REPORT

Report No. 18-042

Place : Dupont, Washington
Date : December 18, 2017
Vehicle : Amtrak 501, Talgo articulated passenger train
NTSB No. : RRD18MR001
Investigator : Michael Hiller

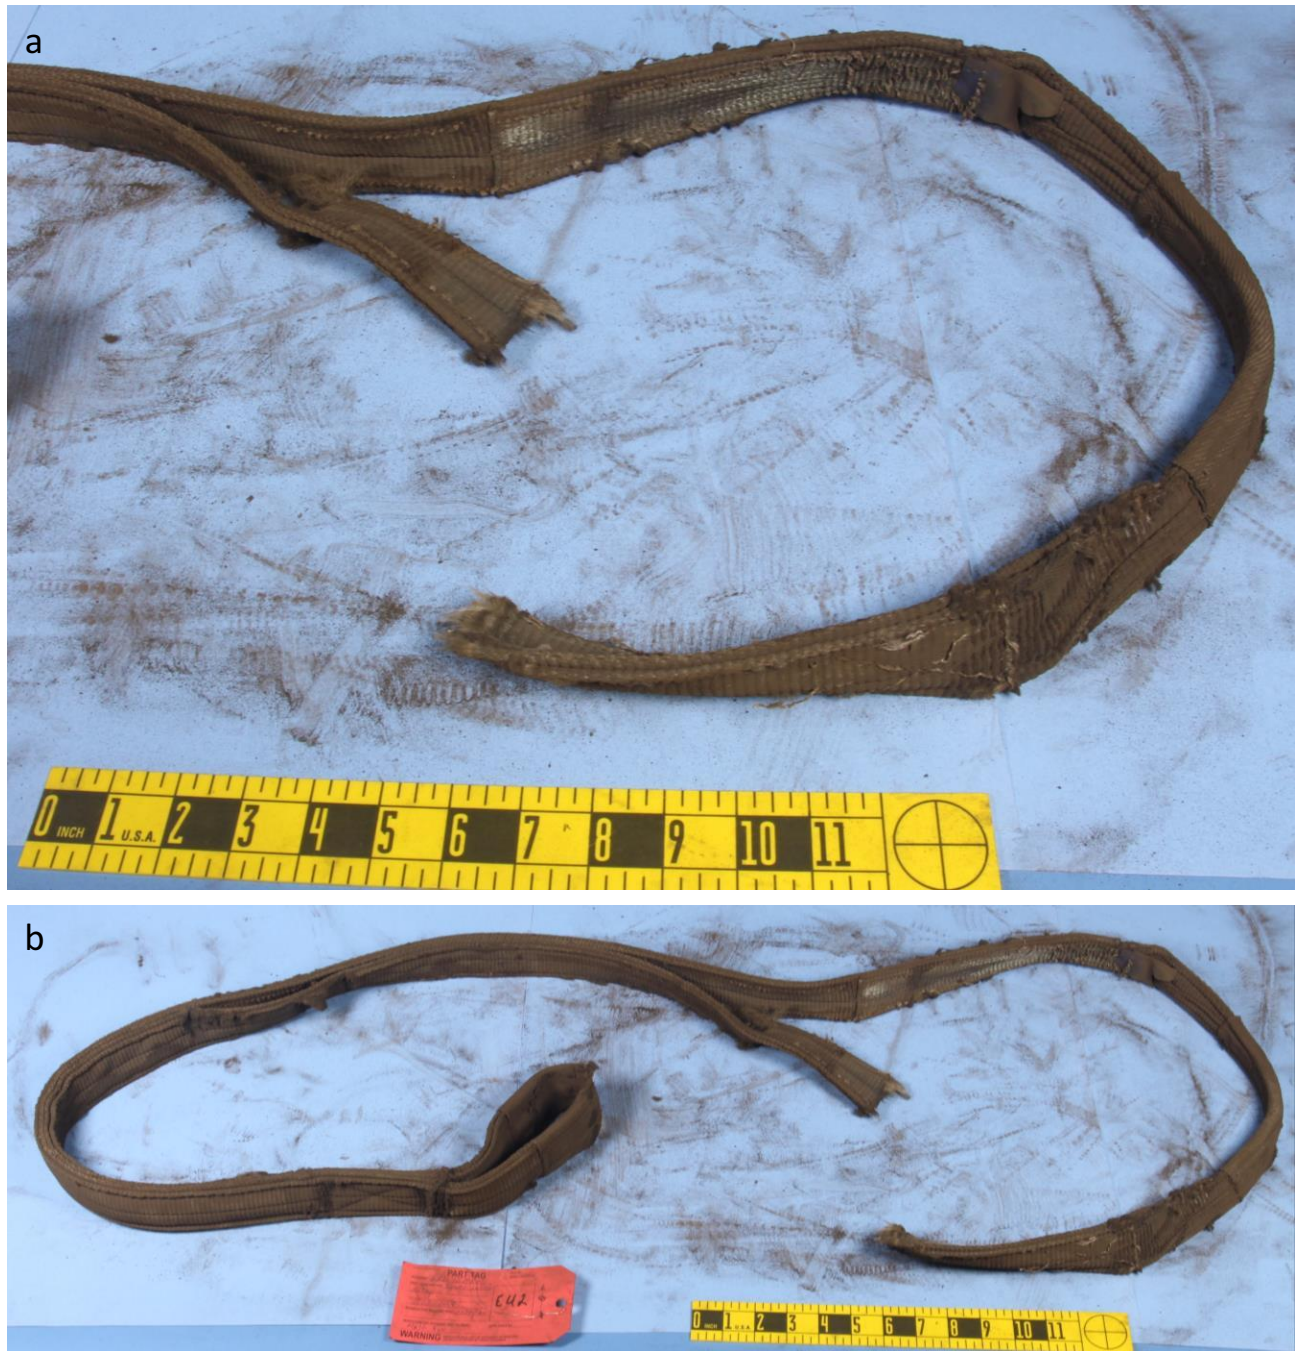
Figure 21 Images after tension testing of web sling EU2 from car 7802, left side. Image (a) is a close view of the fracture region. Image (b) is an overall view of the fractured web sling.

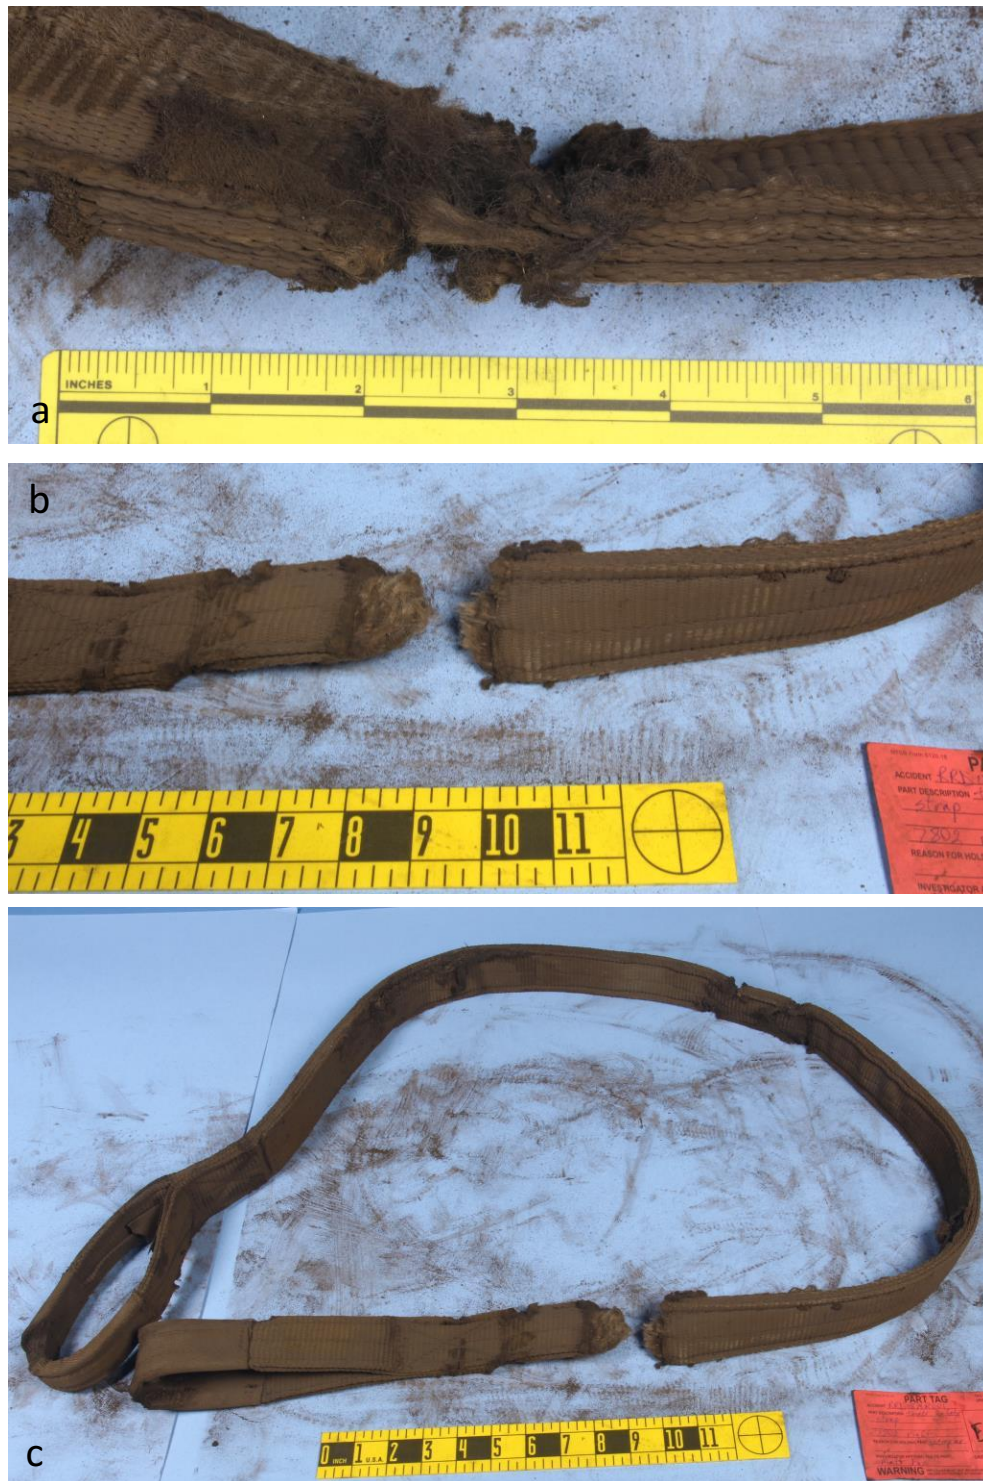
Figure 22 Images before and after tension testing of web sling EU3 from car 7802, right side. Image (a) is a worn area prior to tension testing. Image (b) is a close view of the fracture region. Image (c) is an overall view of the fractured web sling.
